RING MAINTENANCE TIP #3 AVOIDING RING BREAKAGE WITH SINTERED RINGS

THE SINTERED RING, A FINE WATCH

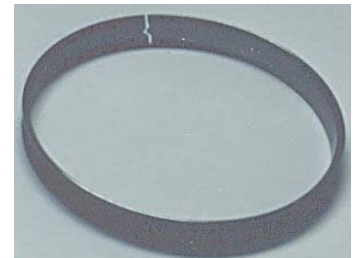
crack, not visible in compression of holder

same ring when removed from holder

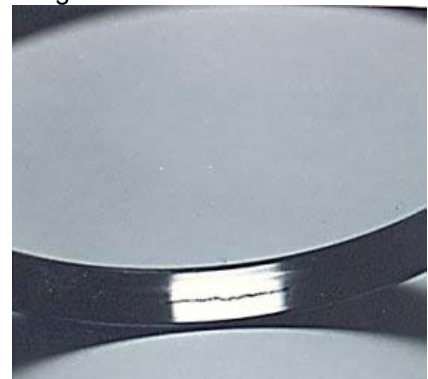
1) **FAULTS PRIOR TO INSTALLATION AND DURING INSTALLATION:** Somewhat rarely, there are faults resulting from manufacture, where rings delaminate laterally (see photograph) from improper pressing and sintering. Some rings are broken during shipment to the plant, while rough handling during installation breaks many others. Visual inspection in receiving will not reveal hairline cracks of rings in their holders. Obvious cracks, chips, and de-lamination can be seen. Inspect all rings prior to installation; do not install faulty rings. Employees must be made aware that rings are very subject to breakage and that a ring assembly should be handled like a delicate watch.

delamination fault

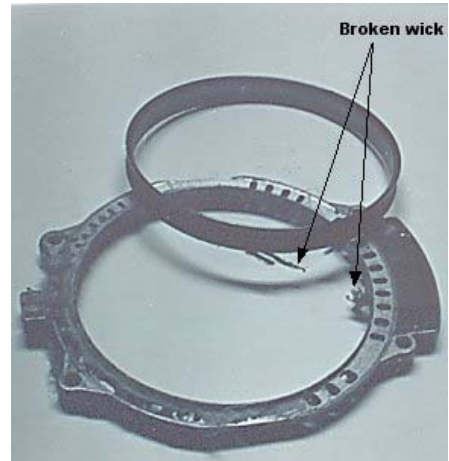
2) **THE CASE OF THE SLIPPING RING:** Occasionally, a ring will loosen in its holder and start to rotate. Too often, this is solved by an overly zealous fixer over tightening the holder on the ring with the comment, "that ring will never slip again." Once the ring had slipped, the wick was broken, thus starving that ring of its oil supply; at the same time, over tightening may either crack the ring, or cause it to go egg-shaped, thus increasing the possibility of broken ends. Employees should immediately report a slipping ring, so that it may be removed for repair.

wick breaks when ring slips in holder

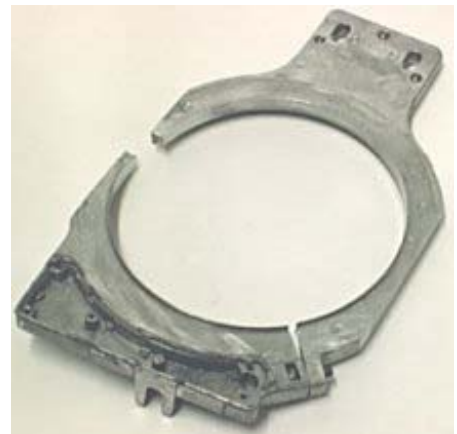
The "Skinned Holder" is a special problem and induces breakage. Take the example of a 6" (152mm) gauge frame originally set up with 4.5" (114mm) rings; this is a safe condition because there is adequate holder width on the sides to support the ring, to prevent vibration cracking. The plant decides they can squeeze a 5" (127mm) ring on the frame to build a bigger package and reduce doffing labor. This is done by skinning a 5" holder (see photo), to squeeze it onto the frame; which substantially reduces the support that the holder gives the fragile ring, and leads directly to a very high incidence of vibration fracture of the ring and holder.

Further, the skinned holder is forced to rub against the separators, causing drag and bending of the holder and resultant breakage. This rubbing action also causes the holder sides (and separators) to wear over time, leading to a further loss of support for the ring and vibration fracture. Very often, the skinned holder was not equipped with nylon wear studs to prevent both wear of the holder and separator. Epic can add replaceable nylon studs to avoid breakage from wear and bending from holder contact.

the fragility of a "skinned" holder

The skinned holder should be avoided. Locate and correct sources of vibration. Secure all holders with star washers. Regularly check holders for tightness. Back mounted holders (holding 5.5" or 140 mm or larger rings) with individual reservoir assemblies should be equipped front stabilization bars. Note that front mounted manifold systems serve the same purpose as the front stabilization bar.
